A cost-effective treatment for severe generalized erosion and loss of vertical dimension of occlusion: laboratory-fabricated composite resin restorations

Michael J. Metz, DMD, MSD, MS, MBA ▪ Brandon M. Stapleton, DMD ▪ Bryan T. Harris, DMD, CDT ▪ Wei-Shao Lin, DDS

This case report describes preventive and restorative treatment planning for a 56-year-old female patient with severe, chronic, poorly controlled gastroesophageal reflux disease and resulting loss of vertical dimension of occlusion. First, the demineralization process was controlled through collaboration with the patient's physician, and measures were taken to restore adequate stimulated salivary flow. Then, for financial reasons, indirect laboratory-fabricated composite resin restorations were adhesively bonded to replace lost tooth structure and reestablish the patient's collapsed vertical dimension. Indirect laboratory-fabricated restorations can be a cost-effective alternative to direct composite resin or all-ceramic restorations for

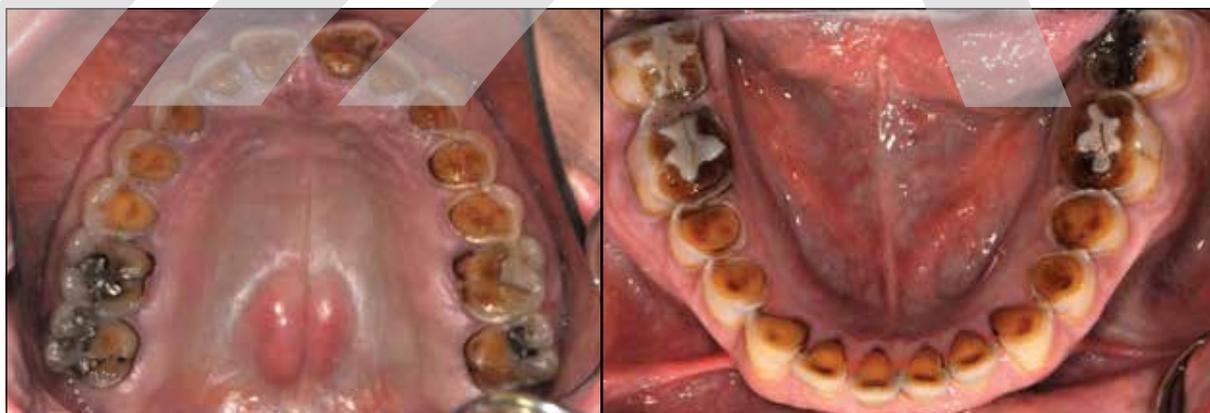
Fig. 1. Extensive erosive destruction of the teeth in a patient with chronic gastroesophageal reflux disease.

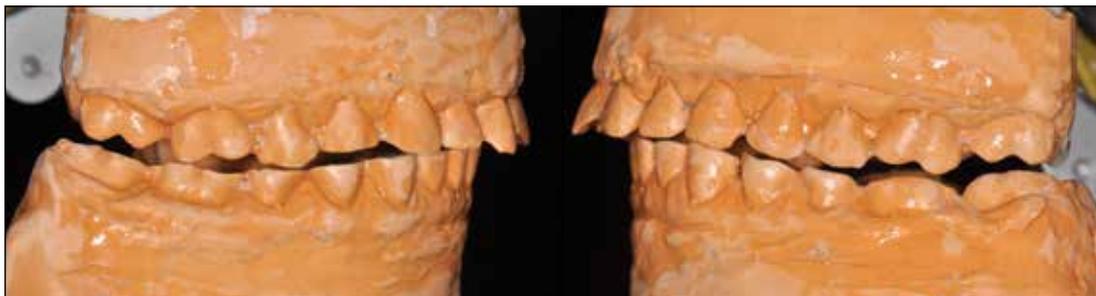
Fig. 2. Corrected VDO set on a semiadjustable articulator.

With her disease under control, she presented for comprehensive dental treatment and a cost-effective restoration of tooth structure and VDO. The comprehensive examination included hard and soft tissue evaluations, oral cancer screening, diagnostic imaging, caries risk assessment, and periodontal evaluation. After the clinical examination was completed and study casts were mounted on a semiadjustable articulator, the patient was diagnosed with generalized advanced erosion of the dental hard tissue and loss of 4.5 mm of VDO (Fig. 2).

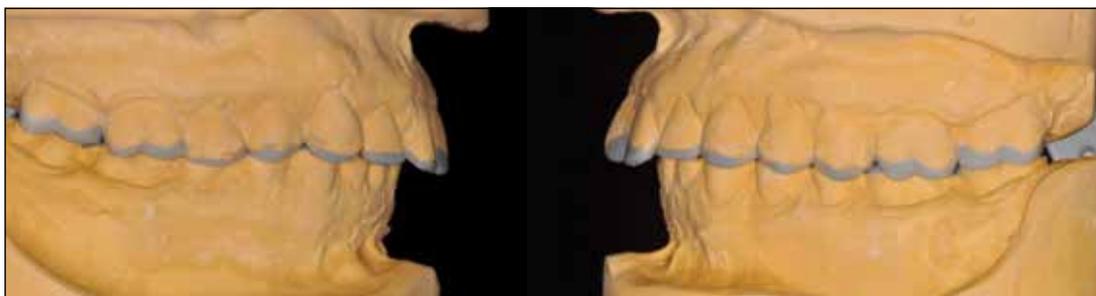
Fig. 3. Diagnostic wax-up at the corrected VDO set on a semiadjustable articulator.

After evaluation of the patient's interocclusal rest space with the mandible in a relaxed position and estimation of the loss of occlusal and lingual enamel, a diagnostic wax-up was performed on the study casts to reestablish her theoretical VDO (Fig. 3). The patient had lost her anterior and posterior functional guidance and started bruxing due to the occlusal disharmony. Her periodontal status was within normal limits, and only localized gingivitis was present around the maxillary second molars.

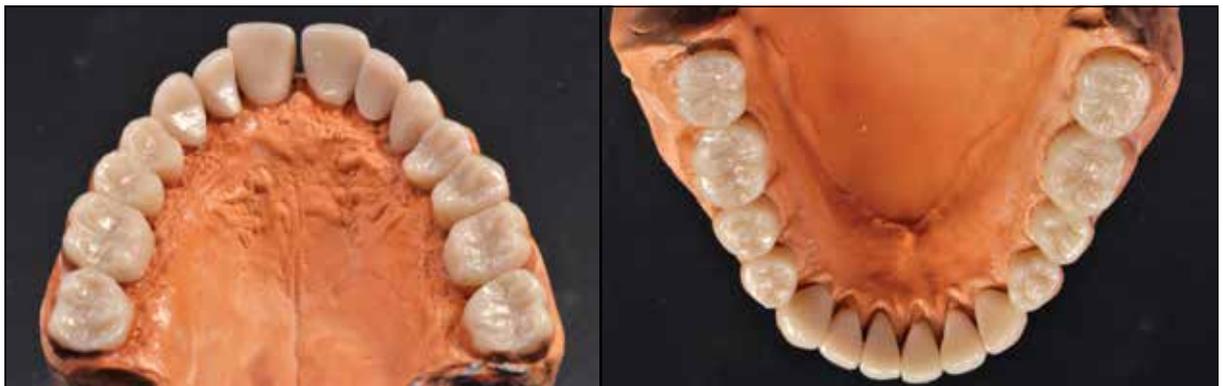
Fig. 4. Indirect composite resin restorations on the master casts.

When they were returned from the laboratory, all restorations were evaluated individually and collectively on the master casts for form, function, and esthetics (Fig. 4). Once evaluated, the restorations were evaluated clinically with try-in paste (Multilink Automix Glycerin Try-in Paste, Ivoclar Vivadent, Inc.). After verification, all restorations were air abraded with aluminum oxide particles (PrepStart, Danville Materials), etched with 9% hydrochloric acid (Ultradent Porcelain Etch, Ultradent Products, Inc.), coated with Ivoclean (Ivoclar Vivadent, Inc.), and lightly coated with Monobond Plus (Ivoclar Vivadent, Inc.) on the intaglio surfaces to prepare for delivery.

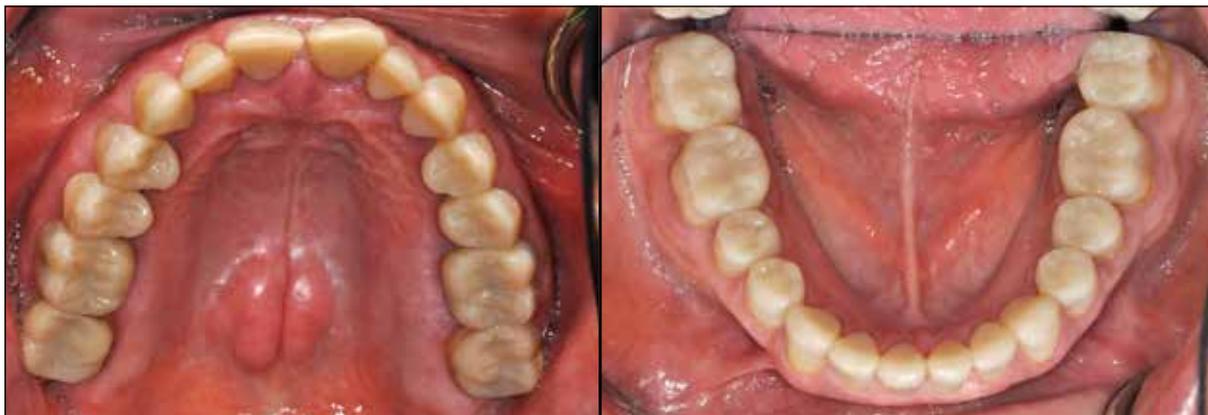
Fig. 5. Indirect composite resin restorations after delivery.

Once all restorations were delivered and occlusal contacts and working movements were verified, the restorations were polished with a serial polishing kit and paste (OptraPol Next Generation) (Fig. 5).
